Quality Alert

What: Sling Sub/Master Link Failure

Where: Gulf Of Mexico, Rigs

When: Feb 21, 25, 2014

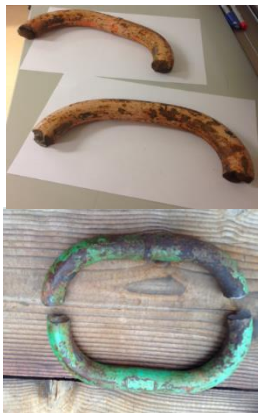
Failed Links

Description of Event: On two separate occasions, a failure has occurred with Swire equipment where a sub-assembly or master link has failed. In both instances, the link broke in two pieces while a lift was in progress. Each of the events have taken place with links from different sling assembly manufacturers. No injuries occurred, however, an increased effort needs to be completed prior to lifting equipment. Until a complete investigation is concluded a recall of the slings equipped with hardware from these two manufactures has been mandated.

1. Follow all inter-company guidelines prior to lifting all equipment.
2. Increase inspections on all master links and sub-assemblies. Remove paint where needed and check for cracks and wear. Do not lift any equipment that is found to have sub-standard lifting gear.
3. Master links or sub-assemblies manufactured by Taylor Chain, **“DO NOT LIFT”**. Please contact Swire for replacement. (800-992-1405)
4. Master links or sub-assemblies manufactured by Apex, **“DO NOT LIFT”**. Please contact Swire for replacement. (800-992-1405)
5. Swire, in conjunction with the sling provider, is in the process of identifying each sling number and location of each sling assembly.
6. **Another communication will be sent out with unit numbers of equipment that each of these sling assemblies are attached, location, and replacement slings mobilized and so that existing slings can be recalled immediately.**

1. Currently Swire personnel mobilizing to all customer locations to remove slings meeting above criteria.
2. All slings sent out will be NDE inspected and tagged in addition to industry standard sling tagging. (This additional tag to be fixed next to standard tag stating NDE inspection date.)
3. As soon as failed links are returned, the exact equipment unit numbers can be isolated and the exact locations will be determined to aid in recall.
4. After failed links have been tested to determine exact cause, further actions and alerts will be sent.
