Quality Alert

What: Sling Sub/Master Link Failure

Where: Gulf Of Mexico, Rigs

When: Feb 21, 25, 2014

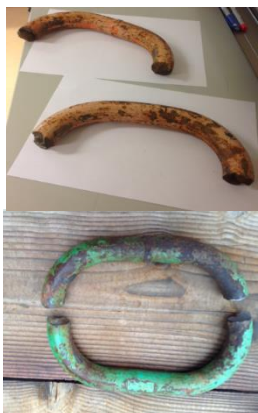
Description of Event: On two separate occasions a failure has occurred with Swire equipment where a sub-assembly or master link has failed. In both instances the link has broken in two pieces while a lift was in progress. Each of the events have taken place with links from different sling assembly manufacturers. No injuries have taken place however an increased effort needs to be completed prior to lifting equipment. Until a complete investigation is concluded a recall of the slings equipped with hardware from these two manufactures has been mandated.

Failed Links

1. Currently Swire Personnel mobilizing to all customer locations to remove slings meeting above criteria.
2. All slings sent out will be NDE inspected and tagged in addition to industry standard sling tagging. (This additional tag to be fixed next to standard tag stating NDE inspection date.)
3. As soon as failed links returned, exact equipment unit numbers can be isolated and exact locations will be able to be determined to aid in recall.
4. After failed links have been tested to determine exact cause of failure further actions and alerts will be sent.
